DEPARTMENT BULLETIN NO. 1232

DAMAGE BY TERMITES IN THE CANAL ZONE AND PANAMA AND HOW TO PREVENT IT.

By Thomas E. Snyder, *Entomologist, Forest Insect Investigations,* and James Zetek, *Specialist in Tropical Entomology, Bureau of Entomology.*[1]

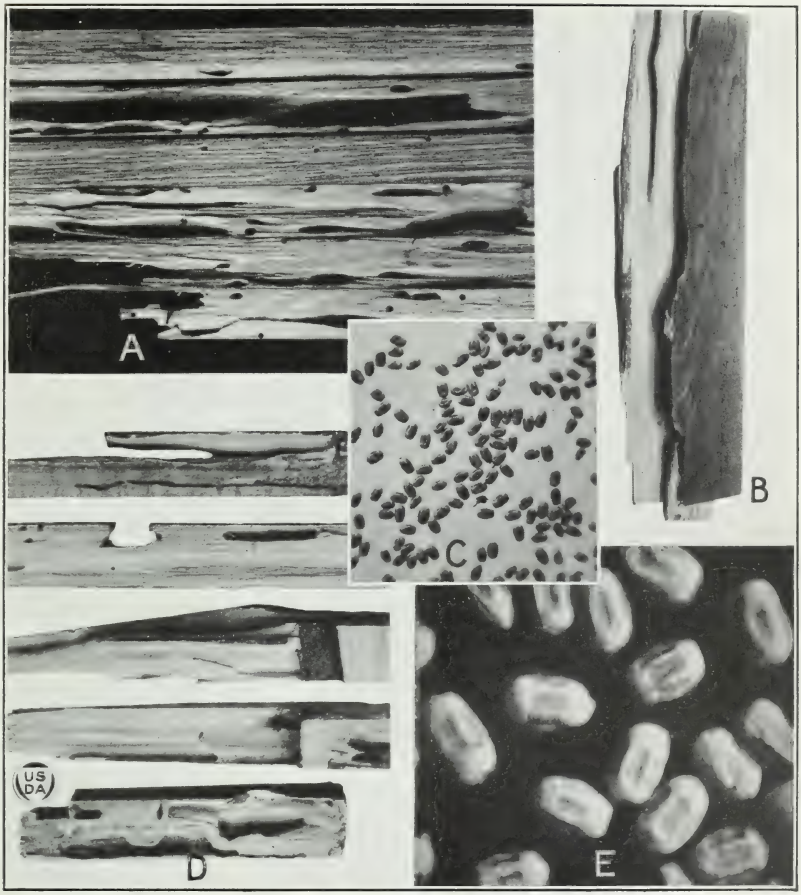
Zetek found soldiers and deälated sexual adults in hard beech wood of a drawer of a desk in Section B of Ancon Hospital on August 30, 1921. The desk had been in this screened concrete building for five years (Pl. III, *A*).

The dry hardwood of a back panel of an organ in the Roman Catholic Chapel at Ancon, Canal Zone, was found by Zetek, on October 19, 1921, to be damaged by this termite. The insects had gone into nearly all parts of the wood (Pl. III, *B*). No winged forms were present and soldiers were very scarce; nymphs of the sexual adults were abundant. Out of the back of this organ as much as 500 cubic centimeters of impressed pellets of excrement (Pl. III, *C*) could have been obtained; the actual size of these pellets is 0.85 by 0.54 millimeter.

DAMAGE BY KALOTERMITDAEI TO THE DRY HARD WOOD OF FURNITURE IN BUILDINGS.

A, Hard beech wood from a drawer of a desk damaged by *Cryptotermes thompsonae*, in a building at Ancon, C. Z. *B*, Back panel of an organ in a chapel at Ancon, damaged by *C. thompsonæ*. *C*, Pellets of *C. thompsonae* near natural size. *D*, Wood from poplar case damaged by *C. thompsonae* in a building at Ancon, C. Z. *E*, Impressed pellets of excrement of *C. thompsonae*, greatly enlarged; actual size, 0.85 by 0.54 millimeter.

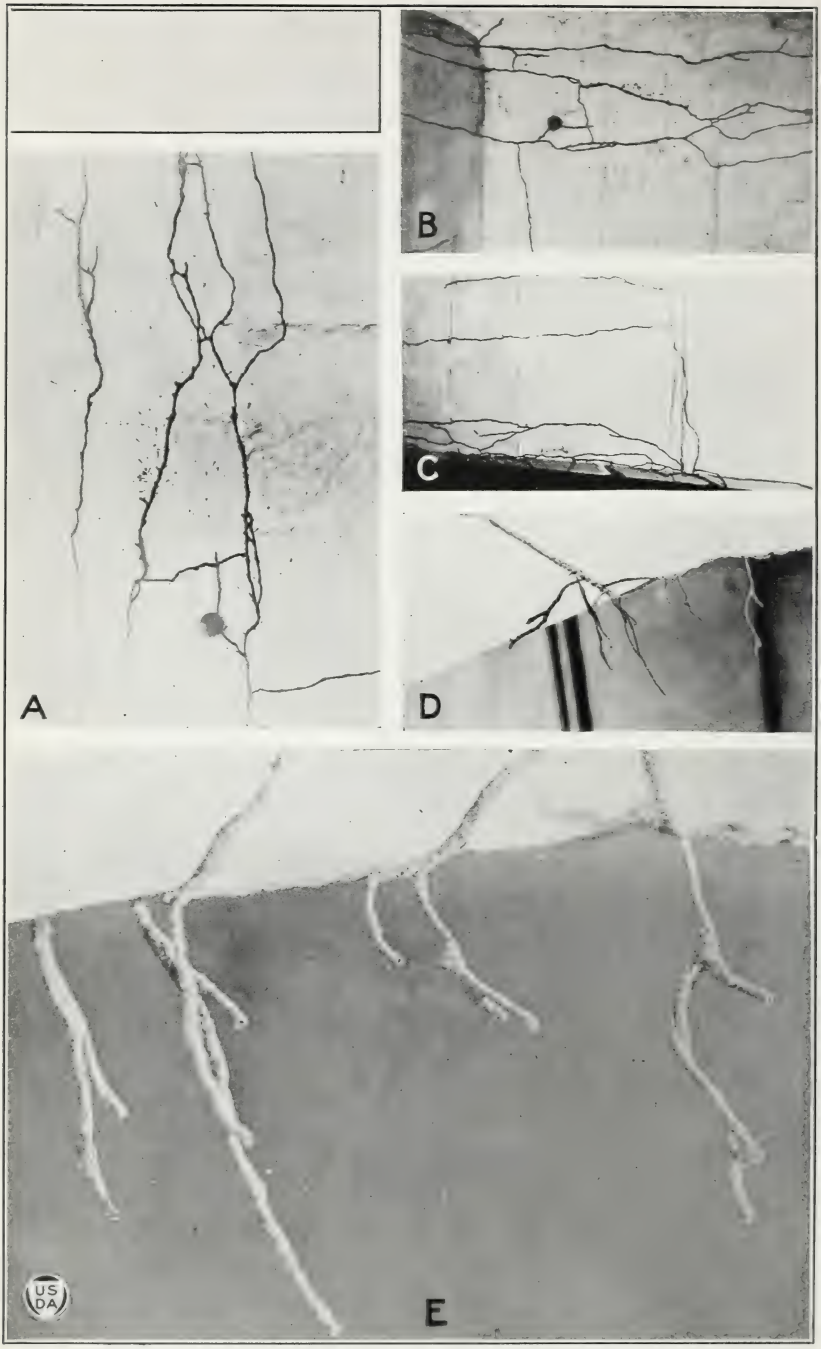
This termite was found also in a manhole opposite lamp post 600, east wall, Miraflores Locks, Canal Zone (lake side) on the same day. They were along the concrete and along the lead-sheathed cables in the manhole.

INJURY BY THE TERMITE LEUCOTERMES TENUIS TO LEAD-COVERED CABLES AT MIRAFLORES LOCKS, C. Z.

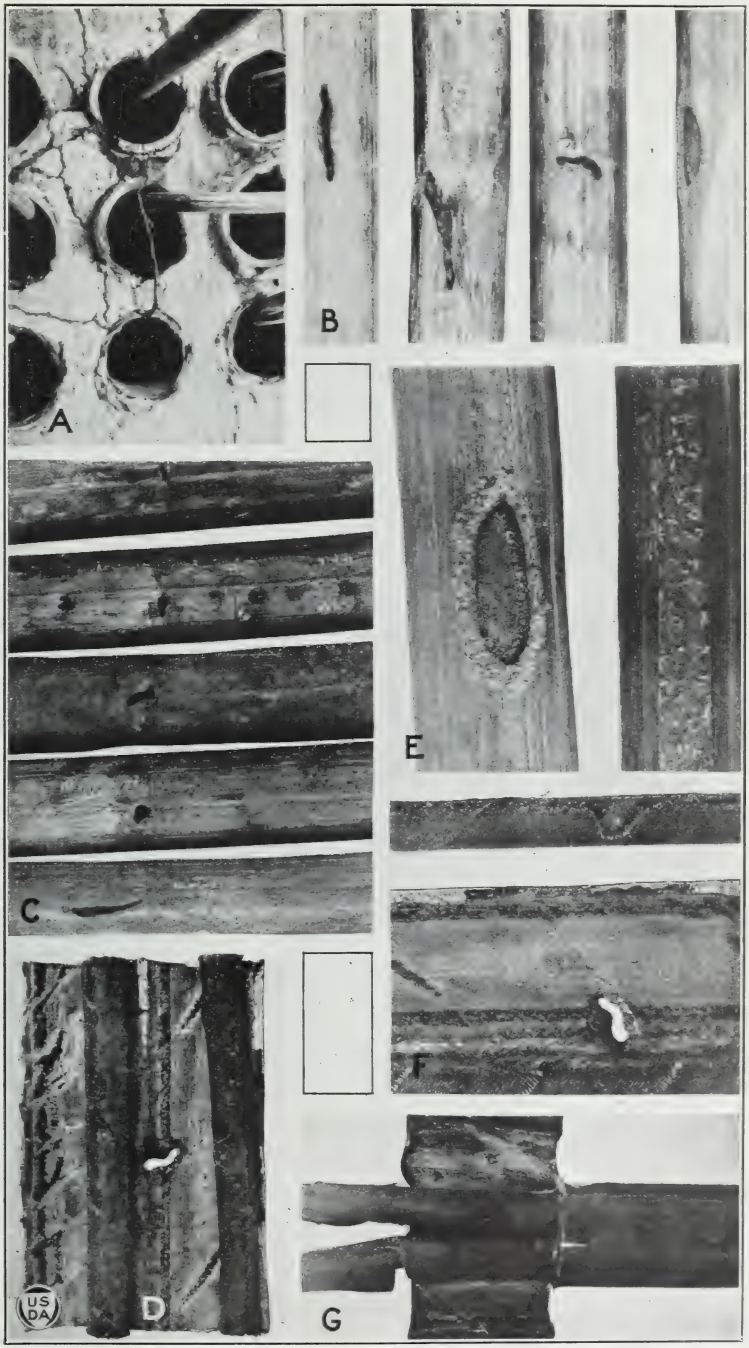
INJURY TO LEAD-COVERED CABLE BY THE TERMITE COPTOTERMES NIGER AT MIRAFLORES LOCKS, C. Z.

On November 7, 1921, Zetek and Molino collected specimens of *Coptotermes niger* in the center wall of Miraflores Locks, Canal Zone. The insects had eaten into the lead sheathing of the duplex cables. This damage to the lead was first noted about November 1, when the telephone service was unsatisfactory. R. S. Mills, acting assistant superintendent of the Pacific locks, then in charge of the Miraflores section, and E. St. Clair Clayton, one of the operators in the control house at the Miraflores Locks, are responsible for calling attention to this injury and for helping in every possible way to get data, specimens of the insects and of the damaged cables, and photographs (Pls. V and VI). M. N. Shaw, cable splicer, first found this infestation about three weeks before the date (November 7, 1921) mentioned above. No positive data as to money value of the loss could be obtained. Fifty feet of duplex lead-covered cable had to be replaced and the cost of the cable, the salary and time of the cable splicer, etc., would easily amount to $100.

The damage was confined particularly to one small section along the center wall of these locks, between two or three of the light posts. The duplex cable, which measures 9 by 19 millimeters on cross section, runs through conduit pipes that are 3½ inches in diameter (Pl. V, *A*). The particular type of injury is well illustrated in the photographs (Pl. V, *B–G*). As a rule, the termites had their galleries attached to the lead-covered cables. At places, for some reason or other, they worked into the lead, perforated it, and then traveled between the two insulated wires (Pl. V, *D*), there being some space between these wires. As this space is not wide enough, they chewed away the insulating material, including the rubber (Pl. V, *D*, *E*). The hole through the lead is usually enlarged on the inner surface. They travel thus between these two wires for spaces of a foot or so, sometimes only for a few inches, and then emerge again and build the galleries along the outside of the lead cable. It is estimated that there was a hole every foot or so (Pl. V, *B*, *C*, *G*). The particular damage to the service is due to the entrance of moisture through these holes.

In one case the termite gallery left one conduit pipe and was continued into space, forming a loop which found no attachment until it reached the lowest point in the next conduit below, and then started to make another loop. (Pl. V, A.) The direction was downward. In the tunnel, where one surface is perpendicular to another, cases were observed where the termites on reaching the next wall continued their tunnel into space; such cases were common, but always appeared to be abnormal and due to the conditions encountered. Such galleries were usually branched, as if the termites were trying to locate a surface for attachment.

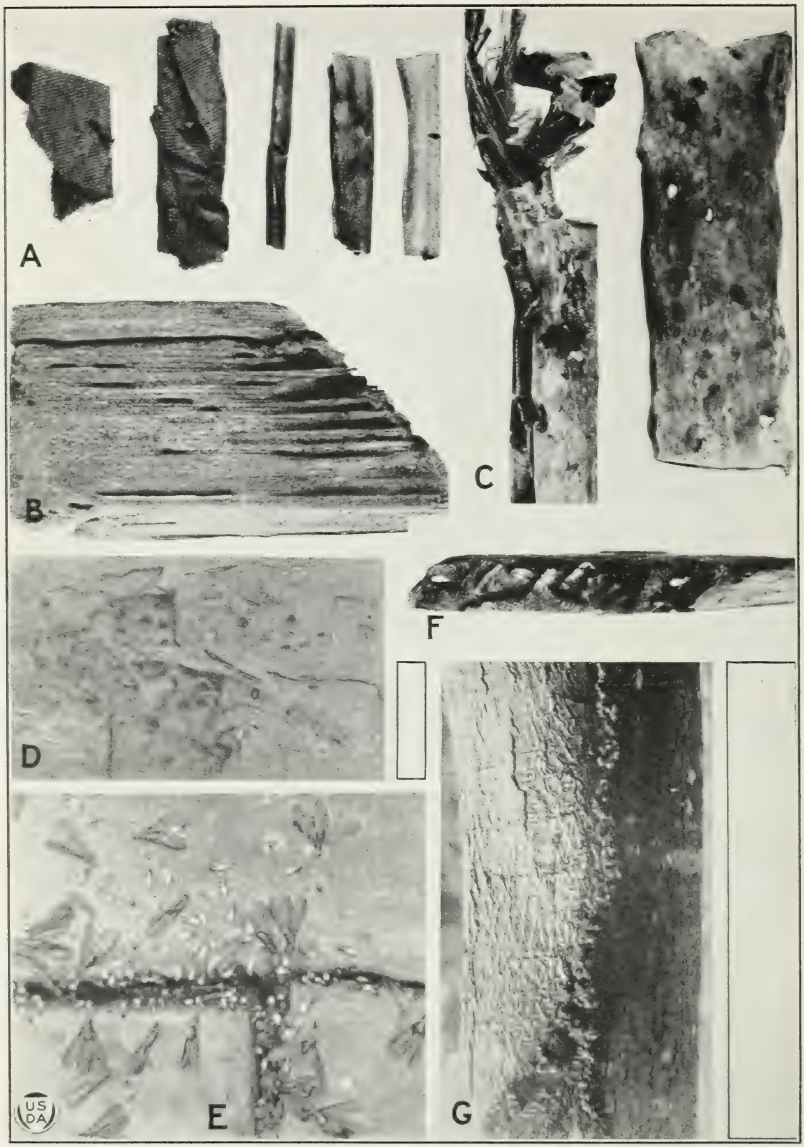
DAMAGE TO LEAD-COVERED CABLES BY THE TERMITE COPTOTERMES NIGER.

A, Tape, rubber, and paper insulation perforated; near Cristobal. *B*, *F*, Damage to wood form under concrete wall cover to tunnel through which cables run at Miraflores Locks. *C*, Damage to lead cable and insulation on this tunnel. *D*, Galleries of *C. niger* in trunk of coconut palm at Ancon, C. Z. *E*, Swarm of colonizing sexual adults of *C. niger*, showing workers and soldiers; from central wall, central tower, Miraflores Locks. *G*, Shelter tubes of *C. niger* on avocado tree at Frijoles, C. Z.

Specimens of the termites inside of the lead-covered cable were collected as well as those in the wood. Specimens of the infested wood, of the damaged cable, and of damaged insulation (Pl. VI, *B*, *C*, *F*) were collected. All of this damage was caused by *Coptotermes niger*.

This injury to lead-sheathed cables is what might be termed a "local" damage. Such cases are not at all infrequent and occurred also at Pedro Miguel and Gatun. If all the wood had been removed at the proper time, however, there would have been none of this damage.

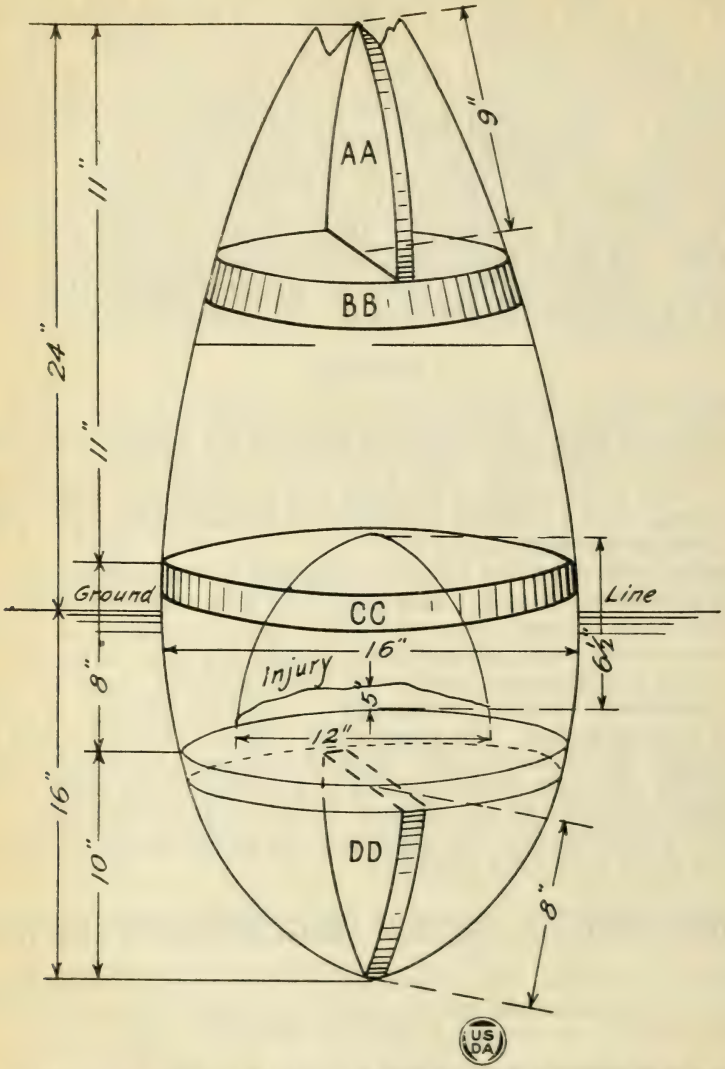
FIG. 1.—Diagram to show general shape and size of trunk of coconut palm shown in Plate VII, its relation to ground level, and location of four sections that were cut and photographed. Location of injury through which termites entered is also shown.

After the trunk had been cut into four parts, as shown in the sketch (fig. 1) (10 inches, 8 inches, 11 inches, and 11 inches), at 4 p. m., July 7, 1922, the four segments were left in the room till next day. At 8 a. m., July 8, Zetek found along the face of the second section (from top) a covered runway or gallery 7 inches

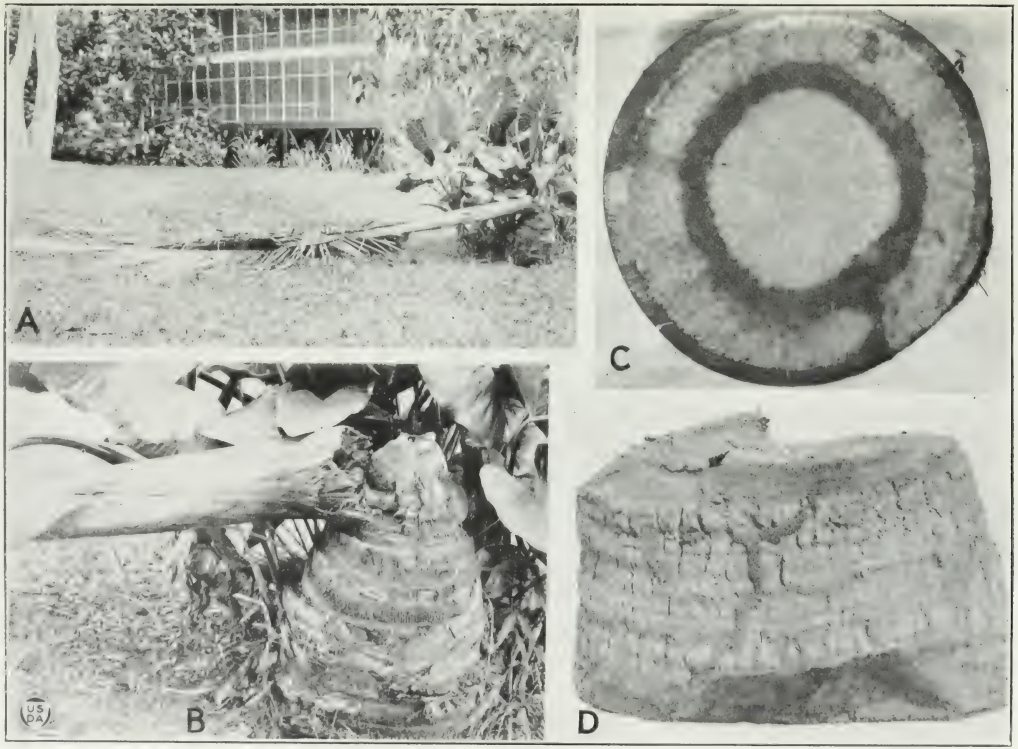
INTERRELATIONSHIP BETWEEN NEMATODES, THE TERMITE *Coptotermes niger*, AND THE "RED-RING" DISEASE OF COCONUT PALM TREES: *A*, Palm C, Nurses' Quarters, Ancon, C. Z., July 7, 1922. This coconut palm had broken off about 2 feet from the ground and had fallen over between 6 p. m., July 6, and 8 a. m., July 7. *B*, Closer view of same palm, showing break at end of trunk and, at base, upper part of injury through which termites gained entrance into trunk where they had built a secondary termitarium. Part of the trunk at break soft, rot-like in texture, abundantly infested with nematodes. *C*, Smoothed face of section CC (see text fig. 1) of trunk. The red ring is very prominent. Nemas were present in all parts of the section. In the lower right-hand corner is a part of the termitarium. *D*, Covered runways of *C. niger* formed overnight after trunk had been sawed up into four pieces. Larger diameter of trunk about 16 inches. Injury through which termites entered palm is seen in upper part of picture.

There is evidence that *Coptotermes niger* may be a mechanical carrier of the nematode which causes "red-ring" disease of living coconut palms. A coconut palm (Pl. VII, *A*), about 5 years old,

INTERRELATIONSHIP BETWEEN NEMATODES, THE TERMITE COPTOTERMES NIGER, AND THE "RED-RING" DISEASE OF COCONUT PALMS.

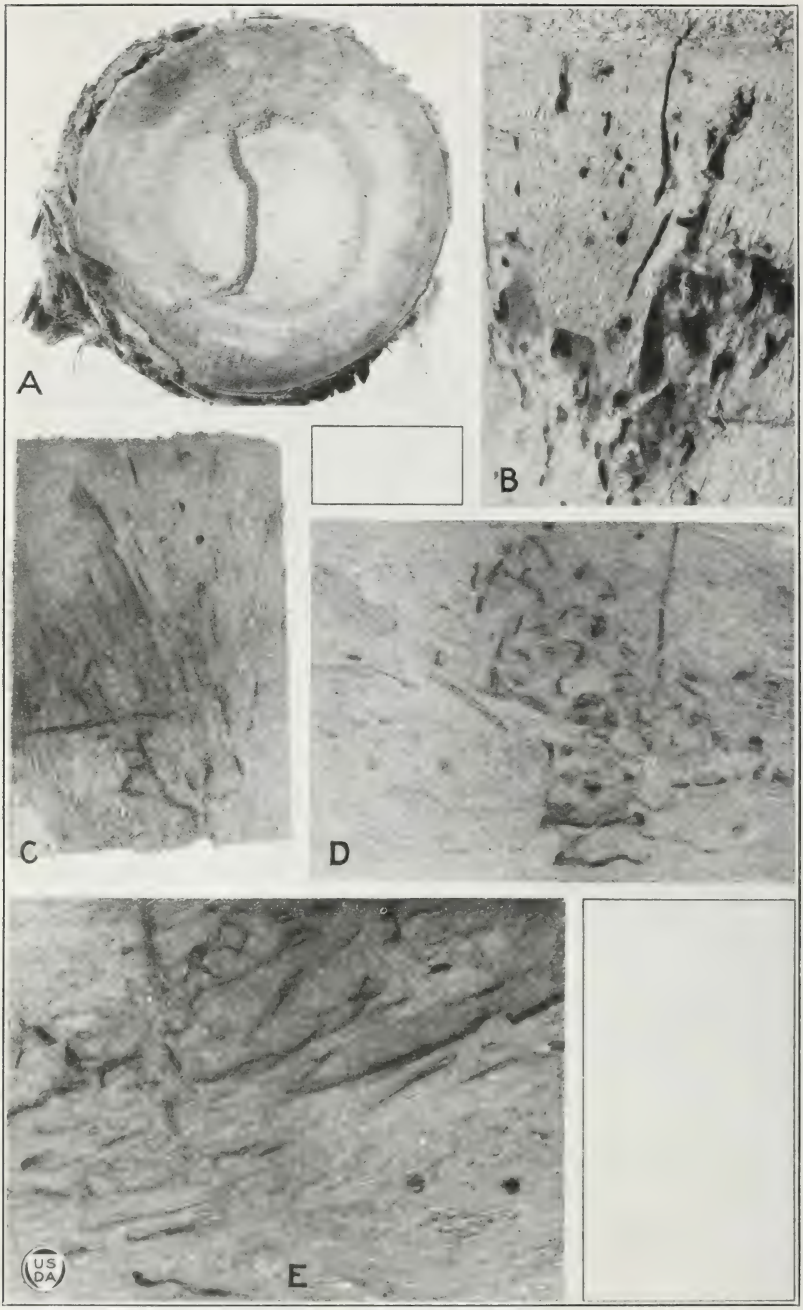
INTERRELATIONSHIP BETWEEN NEMATODES, THE TERMITE *Coptotermes niger*, AND THE "RED-RING" DISEASE OF COCONUT PALMS: *A*, Covered runway of termite built overnight after trunk was sawed up into four pieces. At lower end is seen part of termitarium which had been cut through during sawing. The characteristic ring of the disease is very evident. This section is lower face of CC of the diagram (text fig. 1). *B*, View of termitarium of termite found within trunk of palm. The tissues were abundantly infested with *Aphelenchus cocophilus*. No queen cells were found; only soldiers and workers were present. *C*, Another view of same termitarium. Note cylindrical runways of termites going into trunk tissues. *D*, *E*, Other views of same termitarium.

INTERRELATIONSHIP BETWEEN NEMATODES, THE TERMITE COPTOTERMES NIGER, AND THE "RED-RING" DISEASE OF COCONUT PALMS.

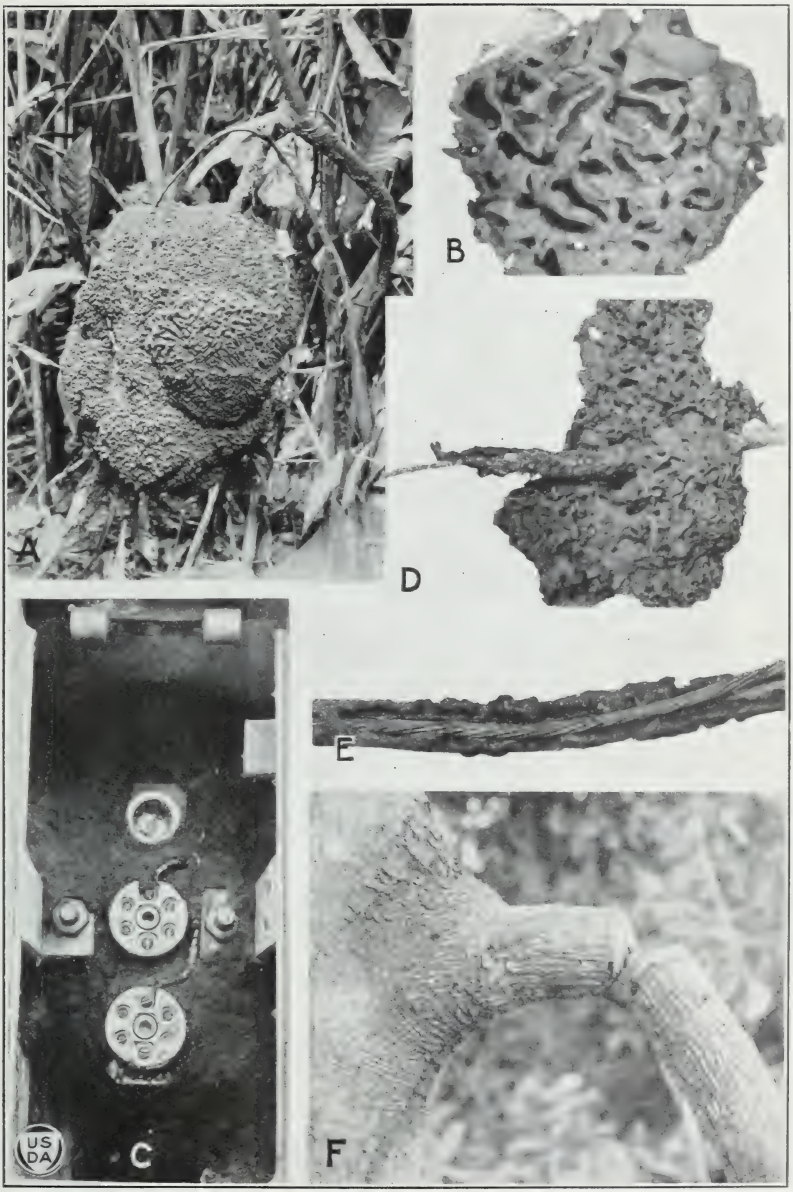
CARTON NESTS AND SHELTER TUBES OF NASUTITERMES CORNIGERA AND INJURY TO ELECTRICAL APPARATUS BY N. EPHRATÆ.

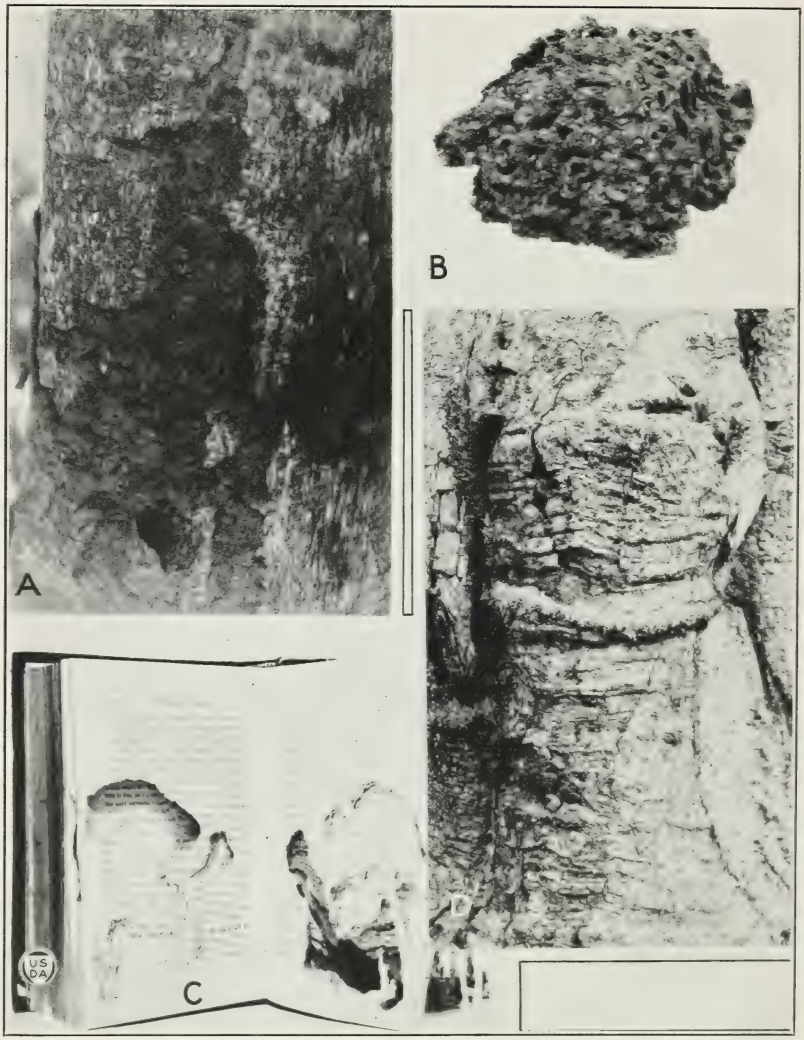
SHELTER TUNNELS AND NEST STRUCTURES AND DAMAGE BY TERMITES, ALSO THE TERMITELIKE SHELTER TUNNELS OF AN ANT

A, Shelter tubes of *Nasutitermes columbicus* on avocado tree, Frijoles, C. Z. *B*, Part of nest structure of a termitarium of *Eutermes debilis* in crotch of tree on Taboga Island, R. P. *C*, One volume of LaSalle University law books, badly damaged by termites, on shelf in room. Three volumes were attacked. The damage seems to have been done in one week's time. *D*, Shelter tubes of an ant similar to those constructed by termites. Photographs by Zetek.
